Abbey Fishponds Local Nature Reserve

Site Management Plan
2021-2026

Prepared on behalf of Vale of White Horse District Council
by Earth Trust

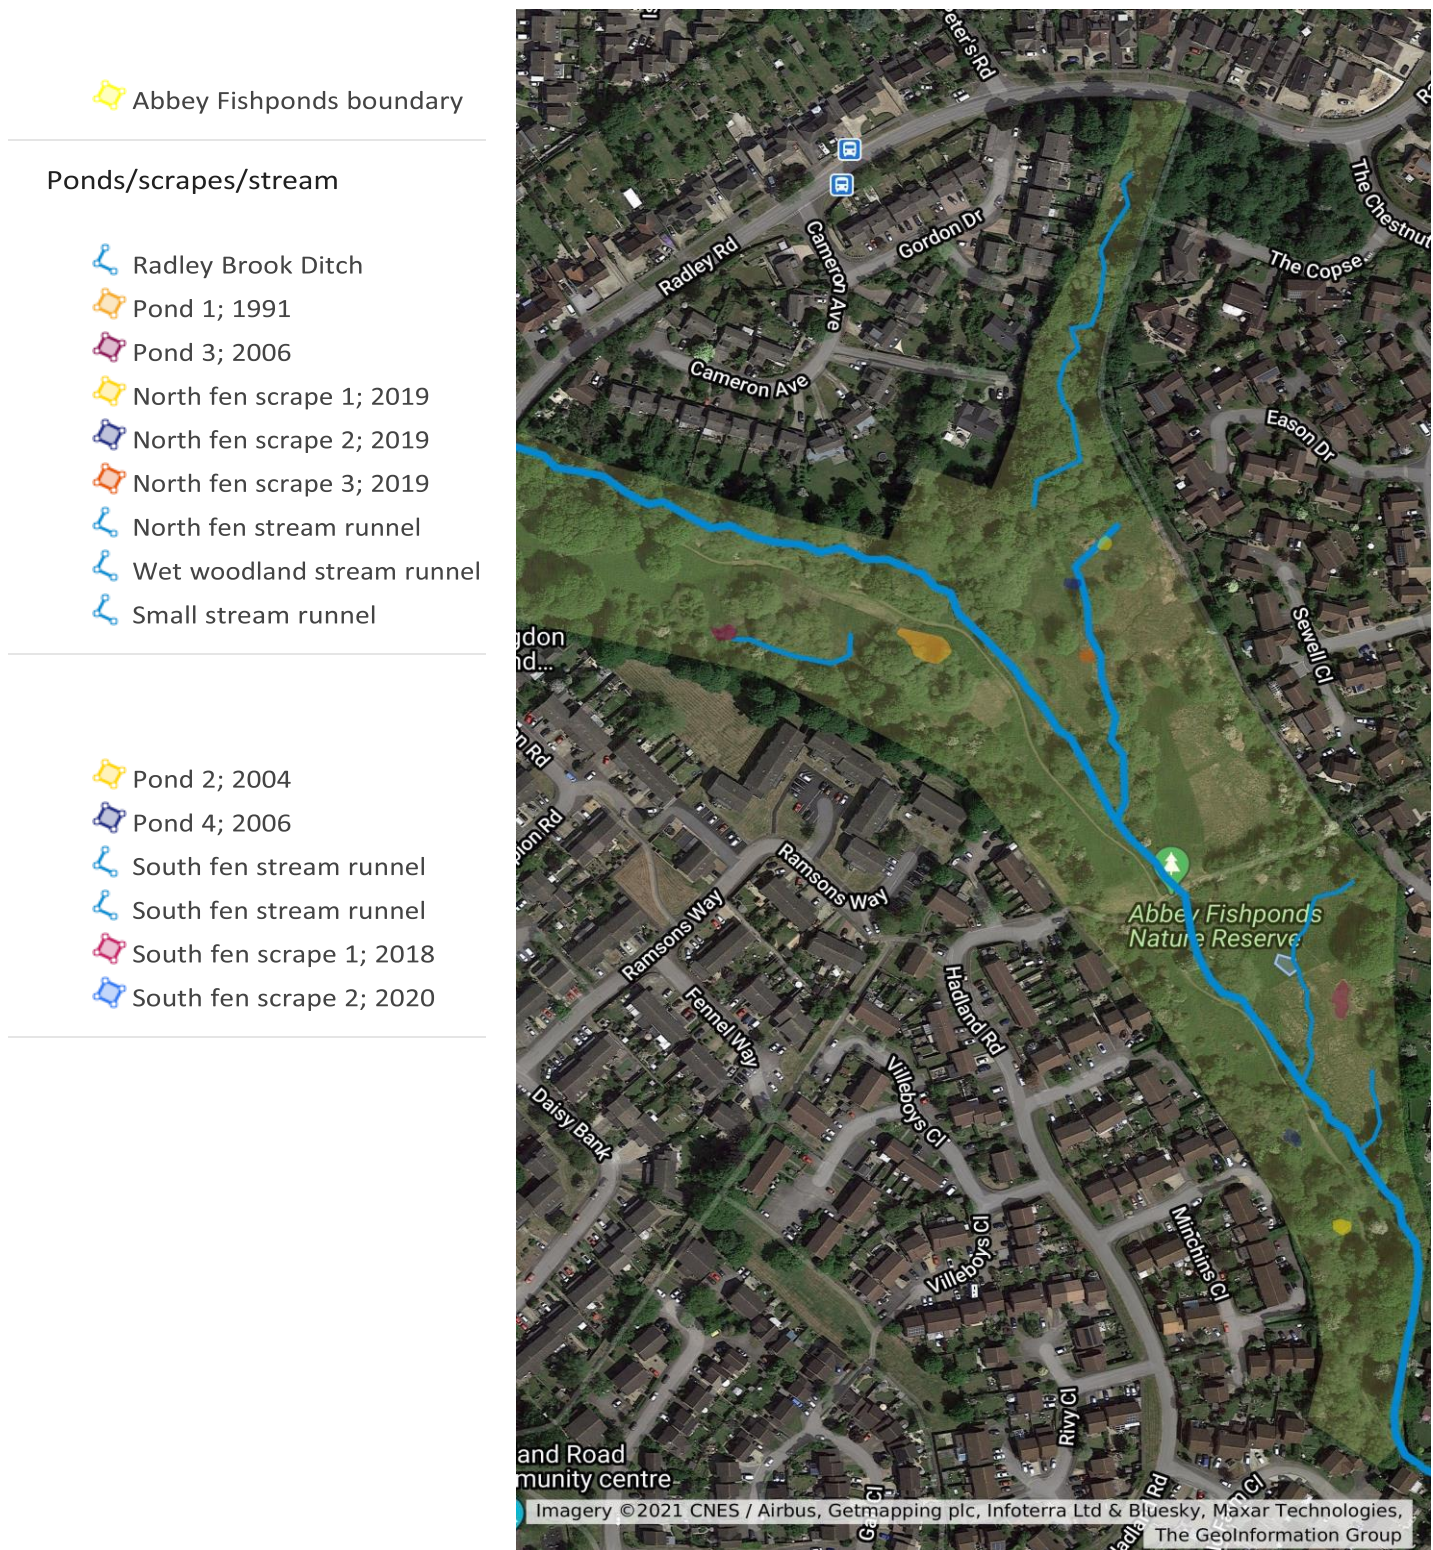
Map 3 – Abbey Fishponds ponds and scrape locations

There are five seasonal ponds/scrapes located within the reedbed and fen areas to the east of the Radley Brook on the reserve, dug in 2017, 2019 and 2020. All have been dug by hand, to a spades depth and made into irregular shapes. The dug out material has been either dispersed as a thin layer across the reedbed/fen or piled in a suitable location under nearby willow scrub

The ponds at Abbey Fishponds are an integral part of the wildlife interest on site and are one of a suite of wetland habitats found on the nature reserve. All of the ponds are stand-alone ponds (i.e. not connected directly to the Radley Brook or linked to other ponds) and located on the west side of the brook. The only other examples of standing water are small seasonal or temporary pools/scrapes in low lying areas e.g. small areas in the central reedbed east of the brook. For location details of the ponds at Abbey Fishponds please see Map 3 below.

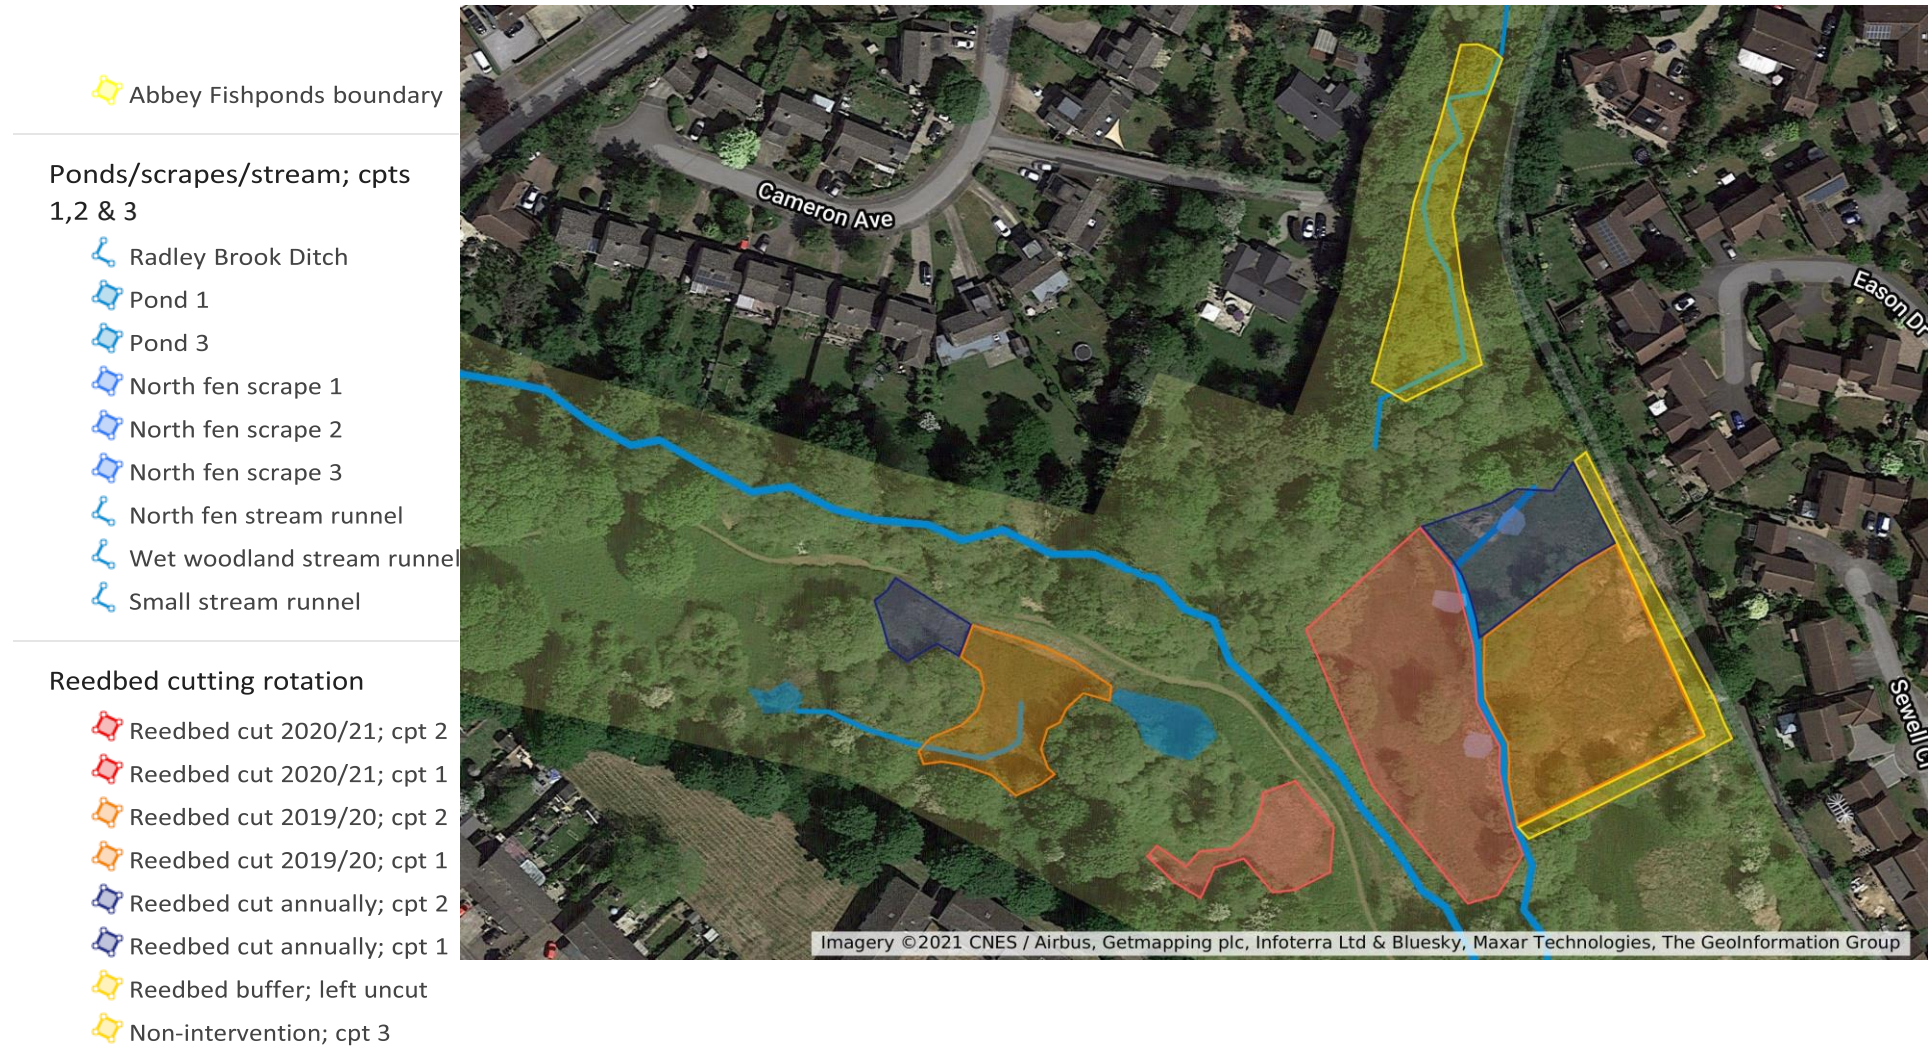
Map 3: Abbey Fishponds Reedbed cutting regime rotations

It has been shown that phytotoxins released during the decomposition of reed litter have a negative impact on the reedbed, reducing diversity (RSPB 2001). Reedbed health may therefore be promoted by reducing the build-up of organic material, including its own litter. Accumulated litter will be removed by raking, to reduce the likelihood of drying out and succession. Cut reeds will be left in piles at the edge of the reedbed (away from the stream) and will provide a valuable invertebrate habitat in its own right or benefit species such as grass snakes which may use such piles of decaying vegetation to incubate their eggs (Langton 1989). The same piles should be used annually, that is unless reed piles become too large and unmanageable. As reed is slow to decompose, burning cut reeds on a burn platform may be considered; but weather conditions would need to be taken into account and the Abingdon Fire Service informed ahead of burning. In addition, vegetation should be cut annually in July/August, where it is growing within the stream/runnels, to provide open water habitat for species such as dragonflies. Cuttings should be put in areas away from the stream or runnels, in drier floristically impoverished areas or in scallops cut into the bramble/scrub edge.
